# BARBOUR MILL DAM

## PHASE I INSPECTION REPORT NATIONAL DAM SAFETY PROGRAM

NJ 00237

Name of Dam - Barbour Mill Dam, Passaic County, New Jersey  
Stream - Unnamed Tributary of Preakness Brook  
Dates of Inspection - 10 and 13 June 1978

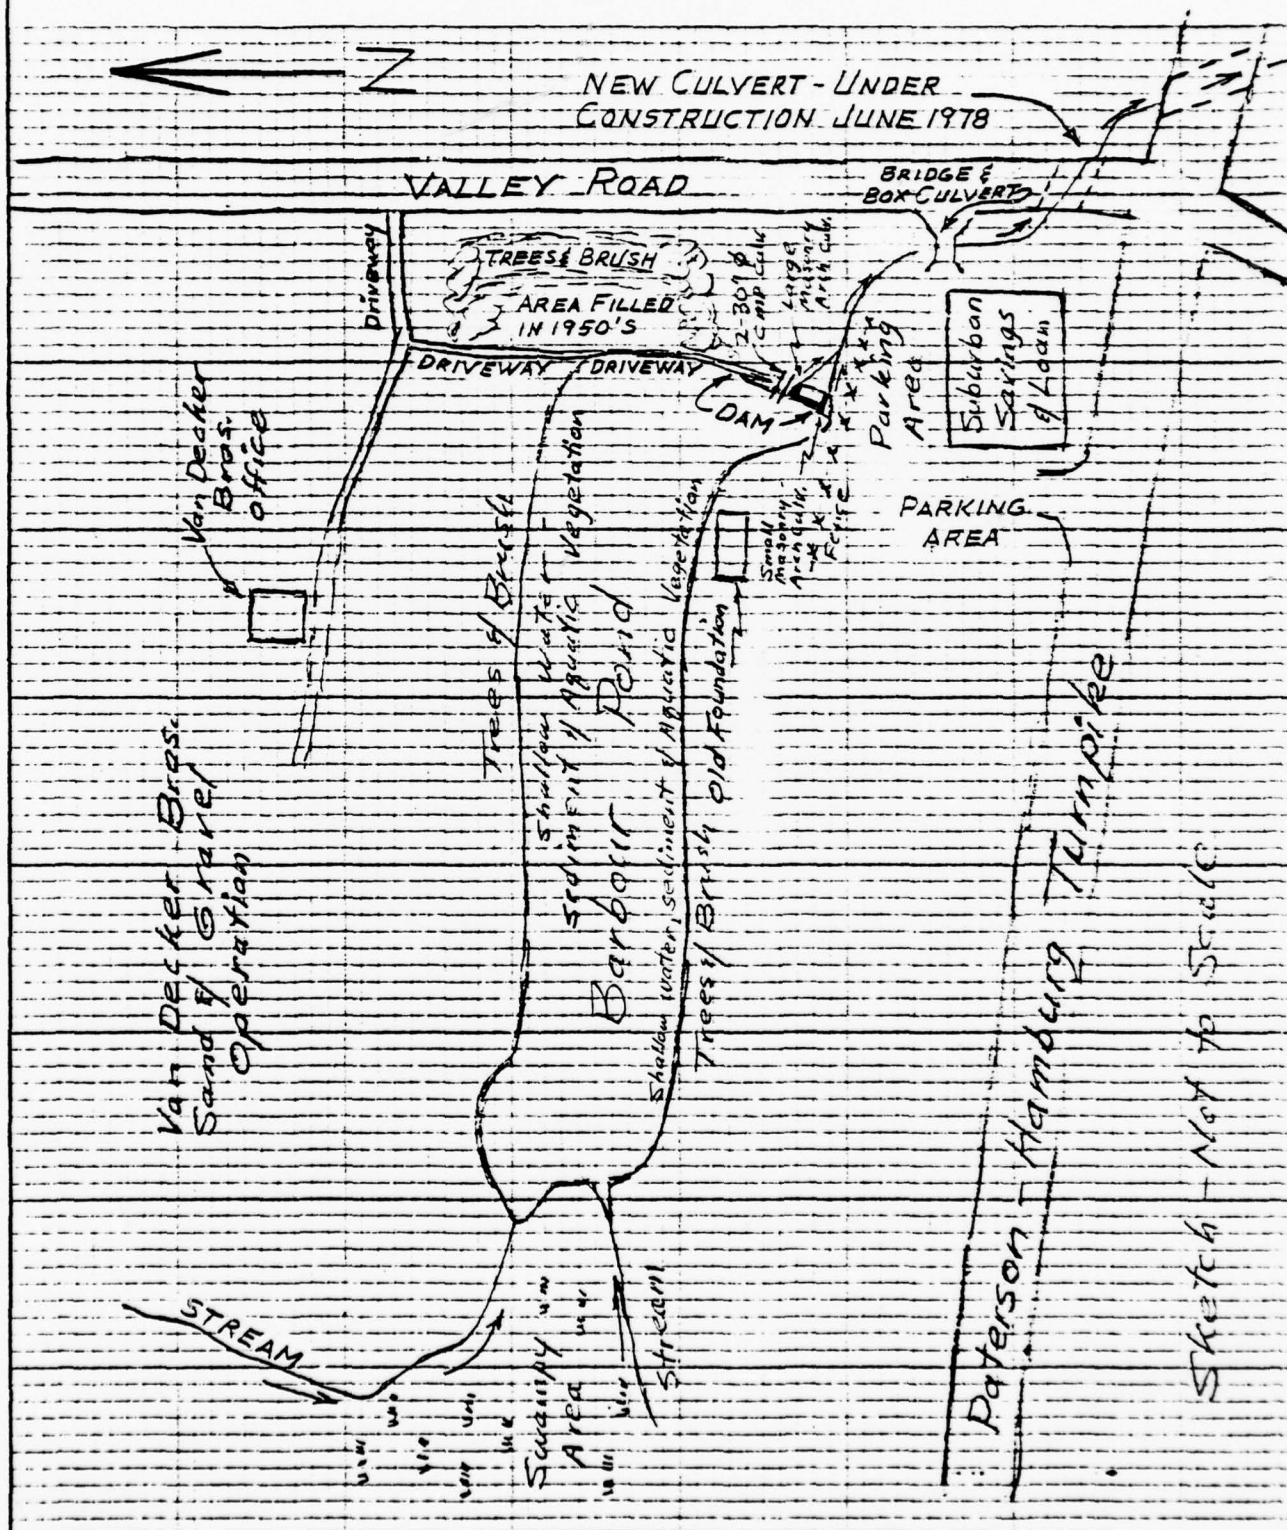
PLATE 1

Barbour Pond, which has extensive deposits of silt and muck as well as abundant aquatic vegetation, is rapidly evolving into a swamp (Plate 1). The maximum depth of pond water at the time of inspection was about seven feet at the concrete head wall, and the average depth of pond water was estimated to have been about three feet.

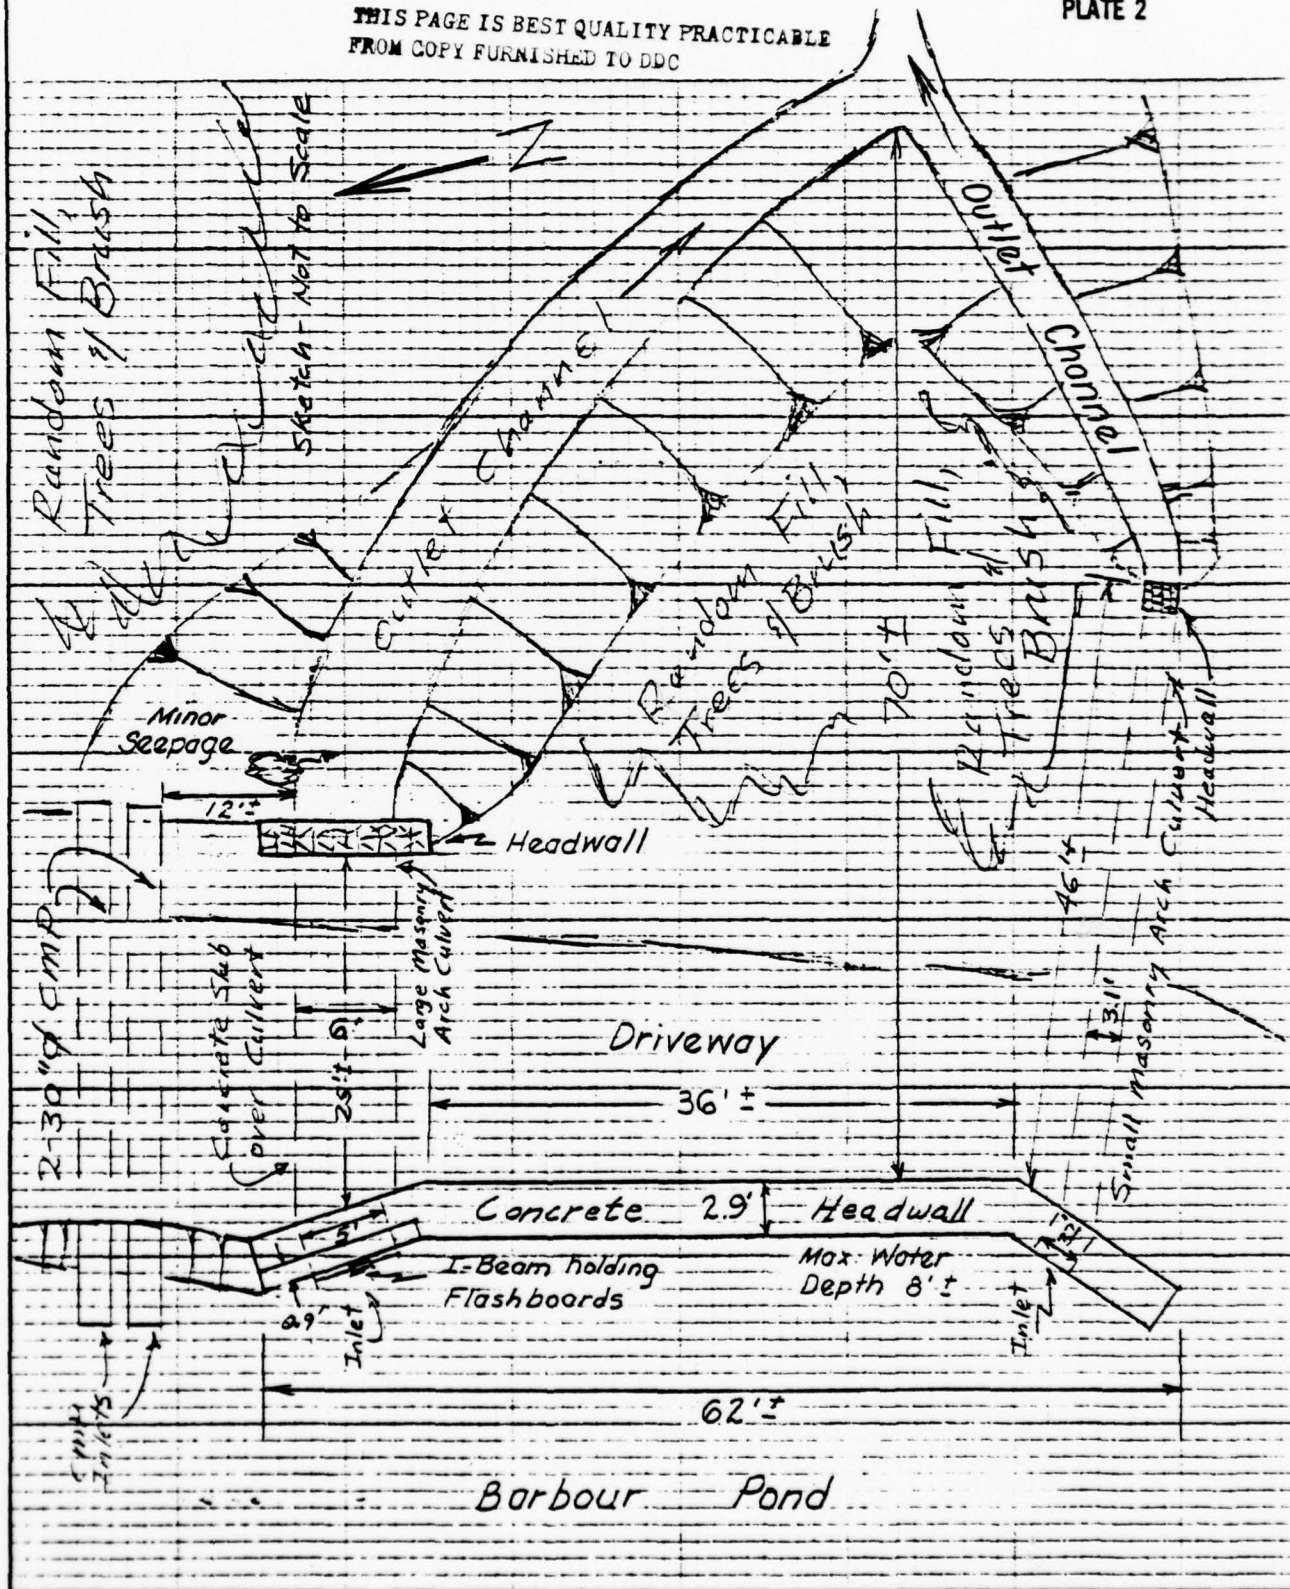
PLATE 2

In addition to the two masonry arch culverts, there are two 30 inch diameter corrugated metal pipes located some 20 feet left of the large masonry culvert (Plate 2). These pipes were reportedly installed by Mr. Van Decker in 1975. The pond level (controlled by flashboards in the masonry arch culvert inlets) was essentially at inlet invert level of the corrugated metal pipes at the time of inspection. Pipe inlet levels are such that the depth of water flow through the pipes will be only about 0.9 foot when the dam is overtopped at a low point on the embankment crest approximately 35 feet left (northeast) of the pipes and also at a low point near the center of the concrete head wall.

Discharge from the corrugated metal pipes flows into the outlet channel for the large masonry arch culvert, and this channel joins the outlet channel for the small masonry arch culvert at a point about 70 feet downstream from the concrete head wall in densely vegetated random fill (Plate 2). From that point, the discharge channel extends about 300 feet further downstream to a bridge from Valley Road to the parking area of the Suburban Savings and Loan Building (Plate 1). This bridge has a clear opening, twelve feet wide by five feet high. Water backed up at the bridge would flow easterly onto Valley Road before overtopping the bridge. A new culvert across Valley Road downstream from this bridge was under construction in June 1978 (Plate 1).

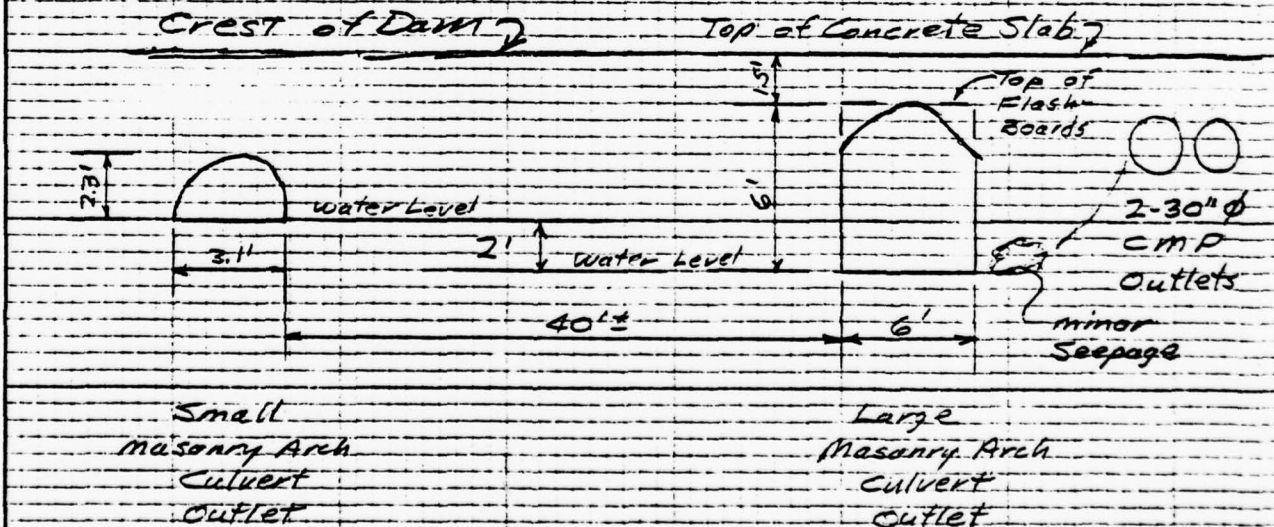
PLATE 3

Low Point on Embankment = 0.9' Free board as at Headwall - is approx 35' left of 30"  $\phi$  CMP.

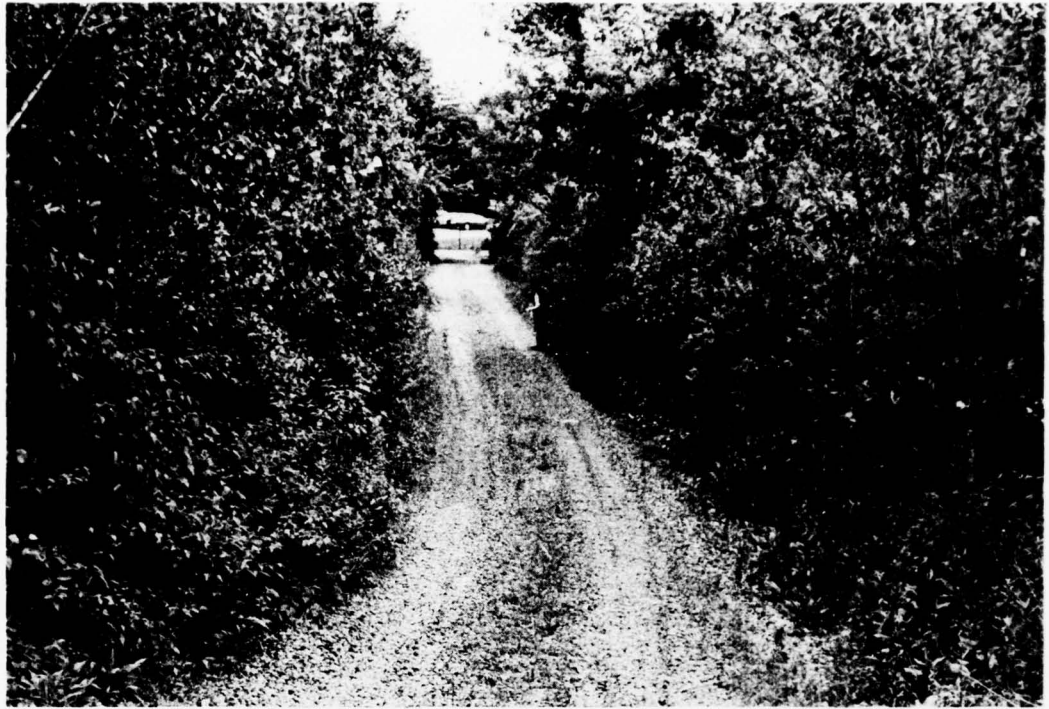
**PHOTO 1**

- Photo 1 View Southwest Along Driveway (From Valley Road, Photo 8) on Crest of Dam; J. V. Hamel Standing at Inferred Left (Northeast) End of Dam Embankment; Suburban Savings and Loan Parking Area (Photo 7) in Top Center of Photo Beyond Outlet Works Portion of Dam - 13 June 1978.

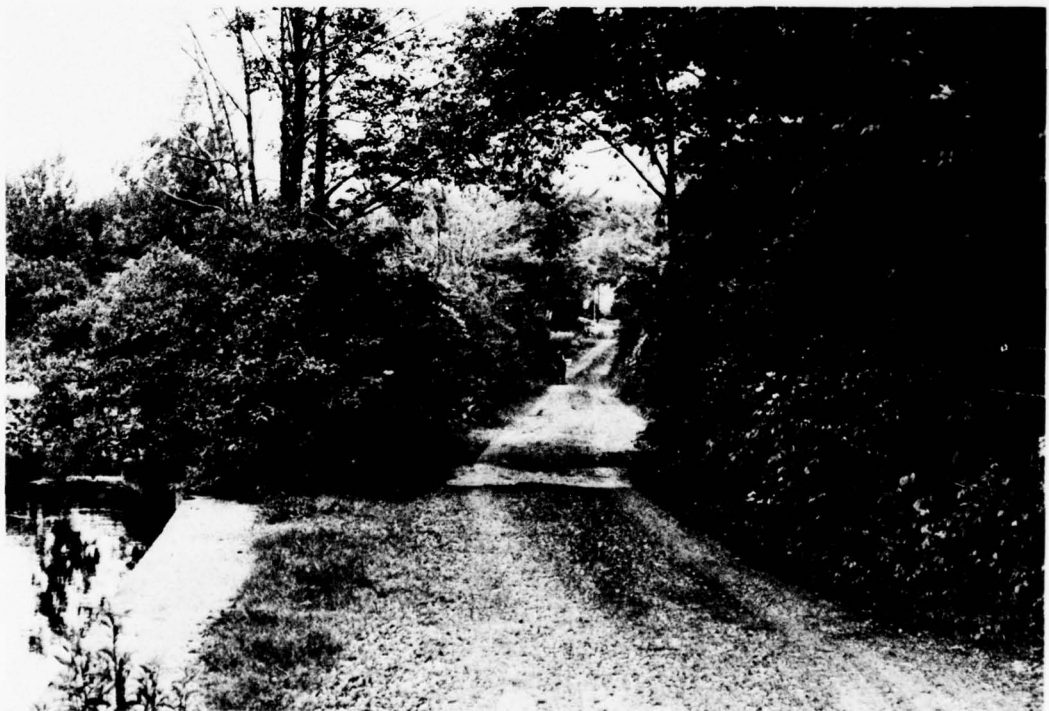
**PHOTO 2**

- Photo 2 - View Northeast Along Crest of Dam From Right (Southwest) Abutment (Adjacent to Suburban Savings and Loan Parking Area, Photo 1); J. V. Hamel Standing at Inferred Left (Northeast) End of Dam Embankment; Concrete Head Wall with Masonry Arch Culvert Inlets in Bottom Left Corner of Photo - 13 June 1978.

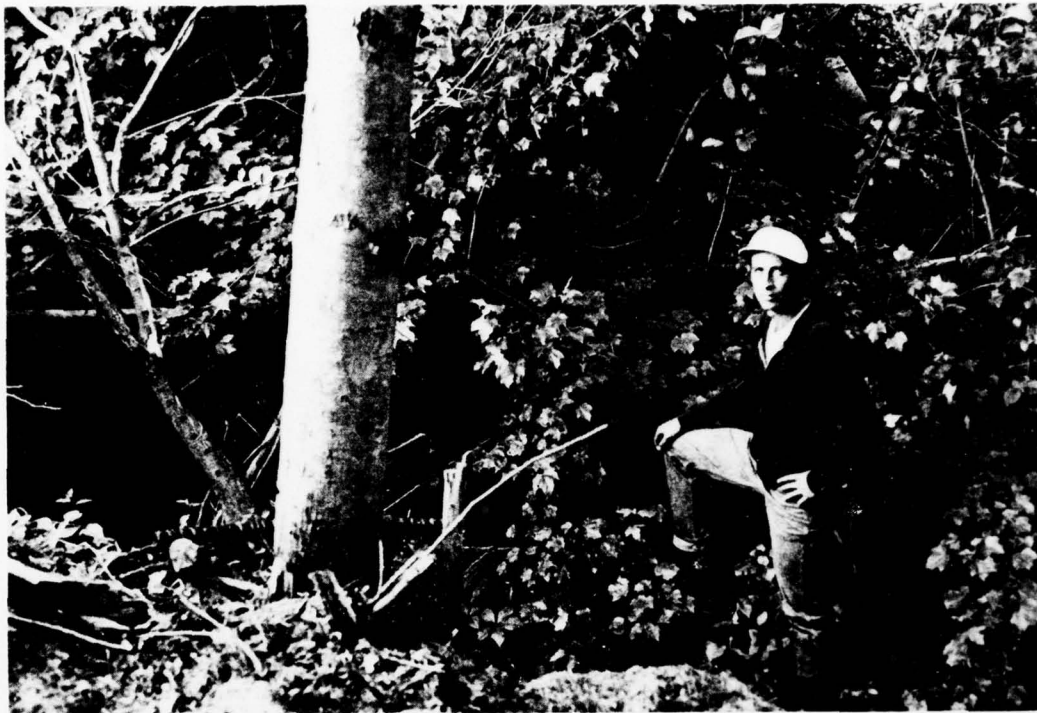
PHOTO 3

- Photo 3 - View East-Northeast at T. J. Dougan in "Jungle and Random Fill" Area Downstream From Center of Dam About 50 Feet Northeast of Two 30 Inch Corrugated Metal Pipe Culverts (Photo 4) - 13 June 1978.

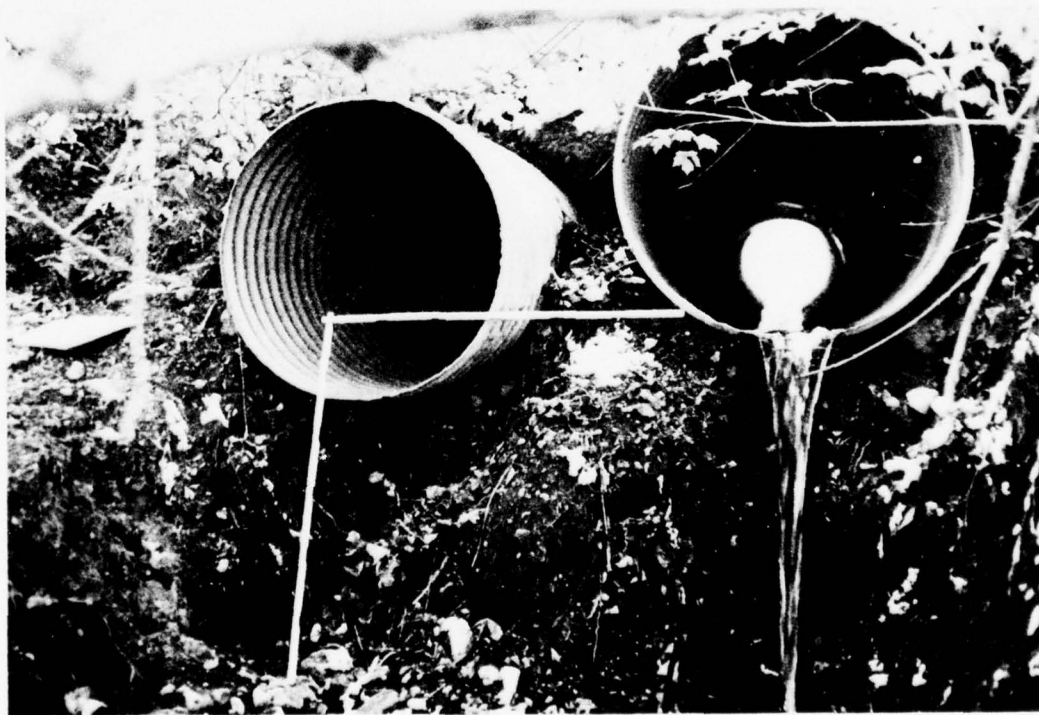
PHOTO 4

- Photo 4 - Close-Up of Outlet Ends of Two 30 Inch Corrugated Metal Pipe Culverts (Left Side of Overall View of Dam) in Downstream Slope of Dam Embankment - 10 June 1978.

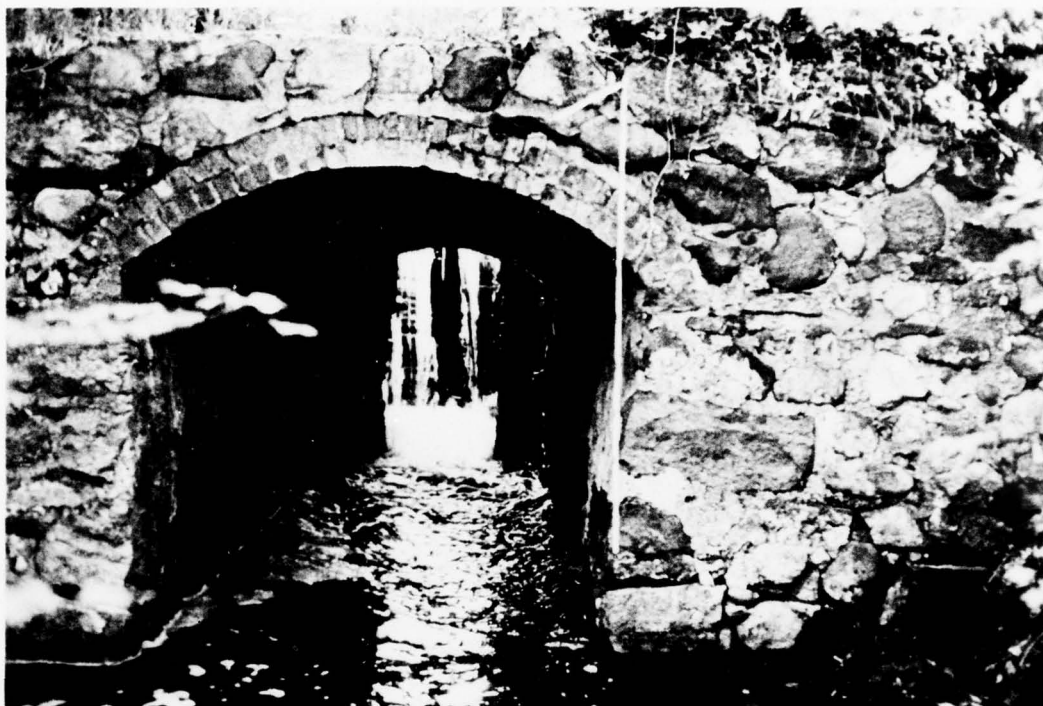
PHOTO 5

- Photo 5 - Outlet of Large Masonry Arch Culvert; Rule is Folded One Foot by Five Feet for Scale; Drop Inlet Visible at Upstream End of Culvert; Minor Seepage From Masonry Wall at Geologists Hammer in Lower Right Corner of Photo - 10 June 1978.

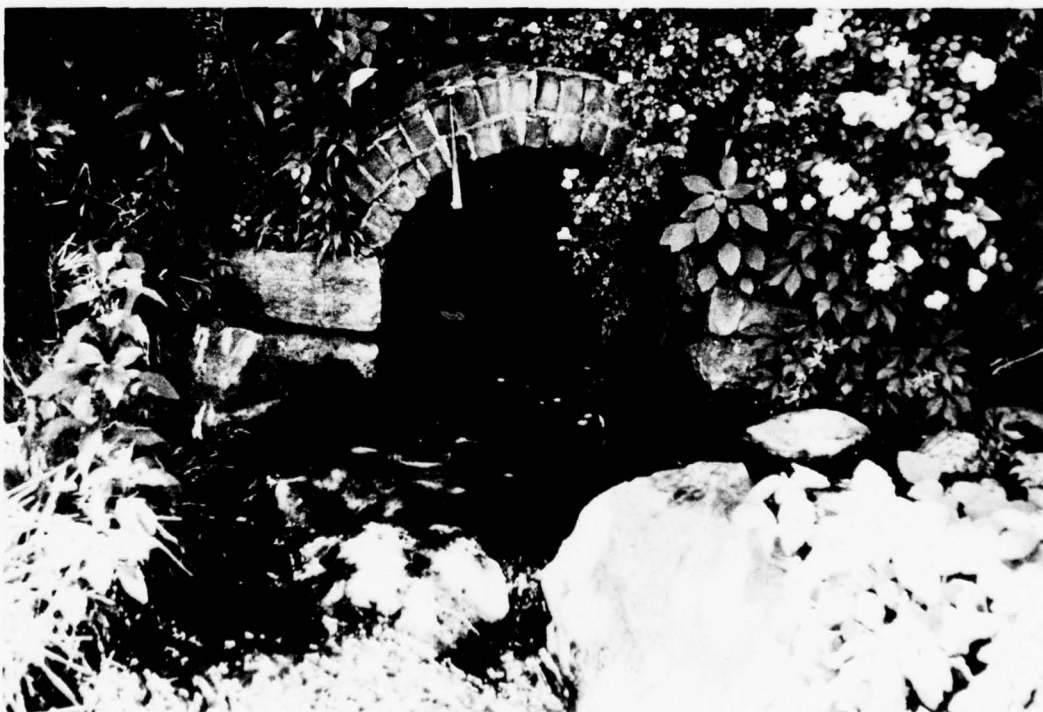
PHOTO 6

- Photo 6 - Outlet of Small Masonry Arch Culvert at Right (Southeast) End of Dam; Geologists Hammer for Scale - 10 June 1978.
- Photo 7 - View Upstream (Northwest) Along Outlet Channel From Dam; Dam Is Behind Trees in Center of Photo; Suburban Savings and Loan Parking Area (Photo 1) at Left Edge of Photo - 13 June 1978.

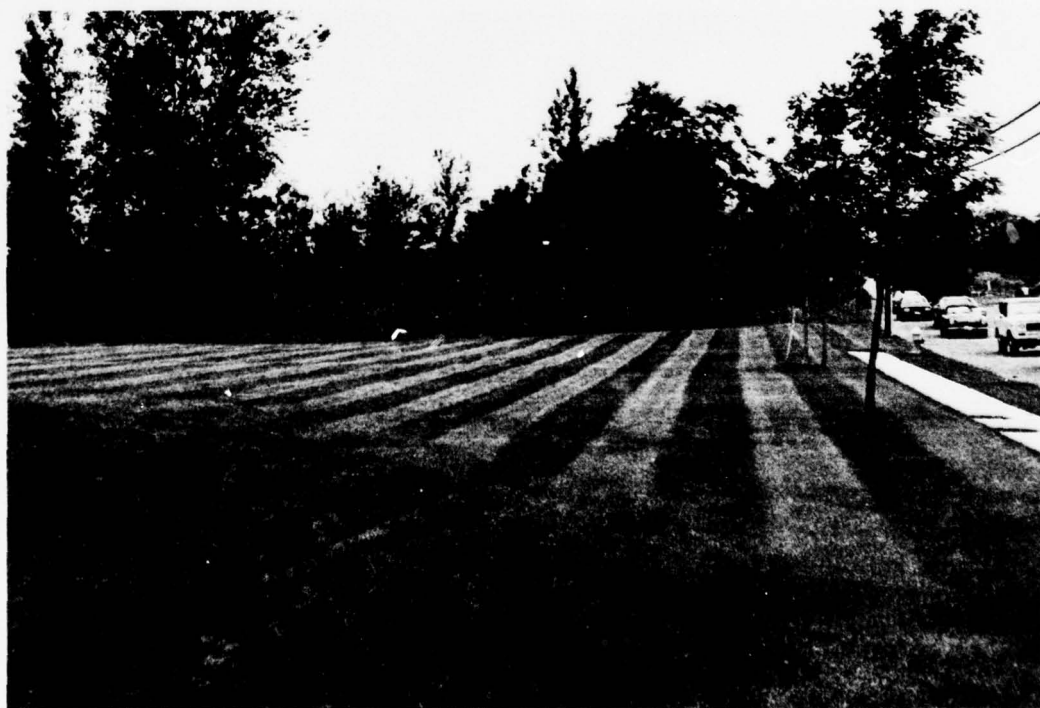
PHOTO 8

- Photo 8 - View North From Same Location as Photo 7; Dam Is Behind Trees in Left Side of Photo; Outlet Channel From Dam Is in Bottom Left Corner of Photo; Valley Road Is at Right Edge of Photo - 13 June 1978.

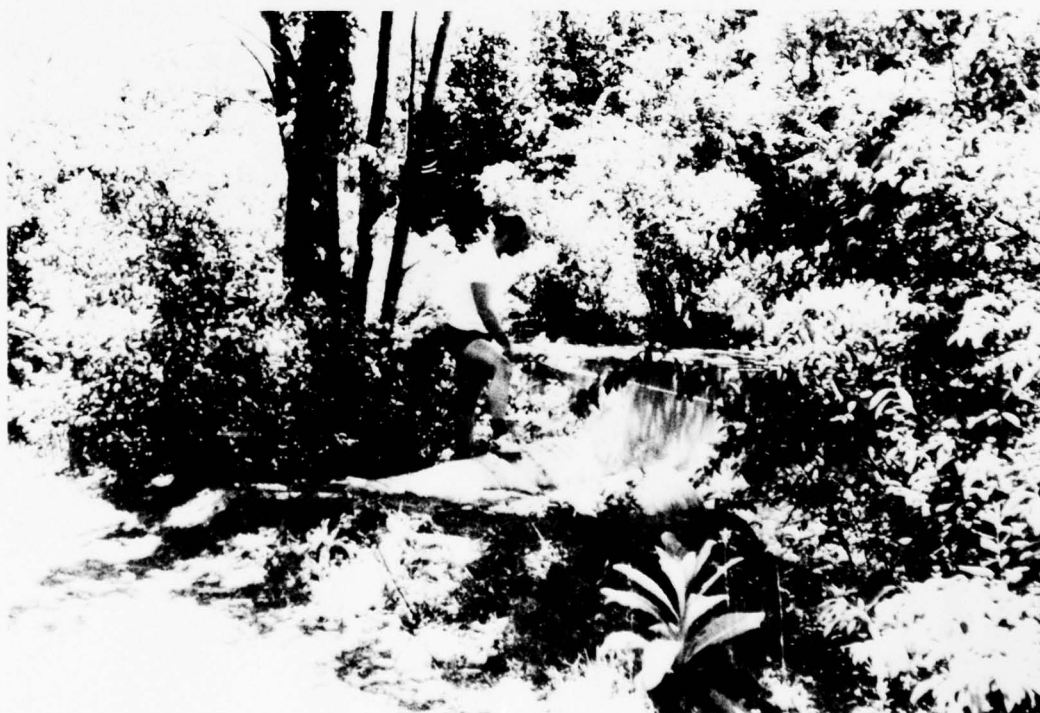
PHOTO 10

- Photo 10 - View Southwest at Inlet Ends of Two 30 Inch Corrugated Metal Pipe Culverts. Inlets Were Installed With Invert Elevation 0.2 Foot Above Normal Pool Elevation; Maximum Depth of Flow in Pipes Is 0.9 Foot Before Dam Is Overtopped; Local Fisherman for Scale - 10 June 1978.
